Connecting Rod - Recondition
コネクティングロッド修正整備

G R A N D S H I P O N L I N E S H O P

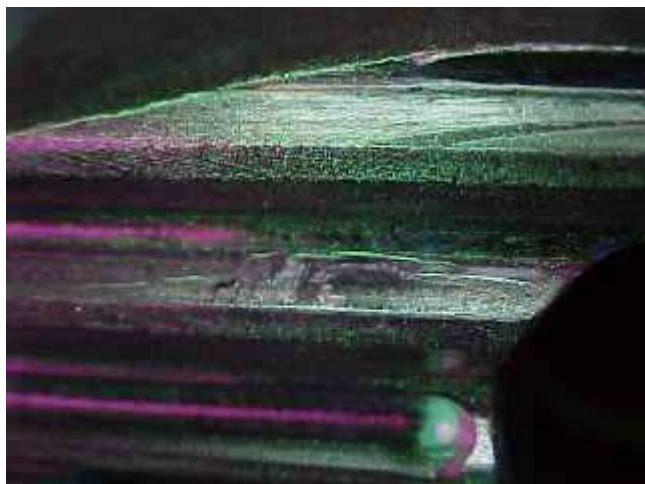
Found crack Magnaflux inspection.
セッション磁気探傷検査、クラック発生。

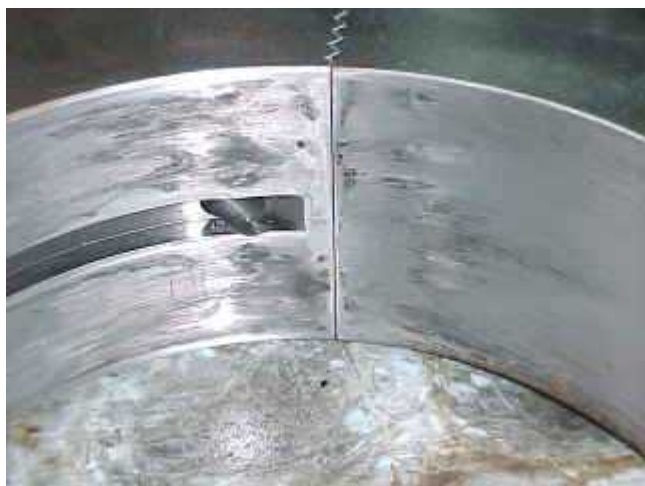
Before recondition big end housing.
大端部修正前。

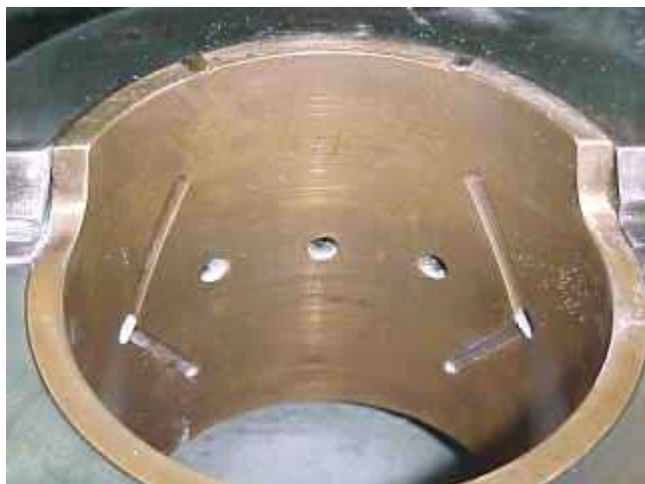
Before recondition small end housing.
小端部修正前。
