# CONNECTING ROD (RECONDITIONED)

MAKER	YANMAR	ENGINE MODEL	M200L
DESCRIPTION	CONNECTING ROD (RECONDITIONED)	PARTS NO.	741616-23010-C
INSPECTION NO.	2L16-2

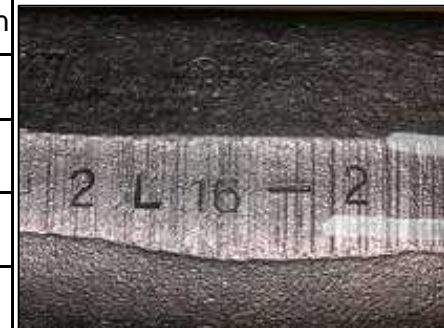
\* Renewed Piston Pin Metal. No. 8-2 Boss 0.5mm Over Size Machined up.

2L16-2 (92-11)	Before Recondition		Out of Metal		Repaired to Boss		Renewed to Metal		After Recondition	
	82	+8 ~ +10	88	0 ~ +2.2	88	0 ~ +2.2	82	+8 ~ +10	82	+8 ~ +10
	X	Y	X	Y	X	Y	X	Y	X	Y
D1	9.7	+17.7	+1.1	+1.2	+1.2	+1.3	-33.3	-37.5	+8.7	+8.8
D2	9.8	+17.5	+1.3	+1.3	+1.3	+1.4	-34.5	-36.8	+8.6	+8.8
