CONNECTING ROD (RECONDITIONED)

MAKER	YANMAR	ENGINE MODEL	M200L
DESCRIPTION	CONNECTING ROD (RECONDITIONED)	PARTS NO.	741616-23010-C
INSPECTION NO.	3A18-10

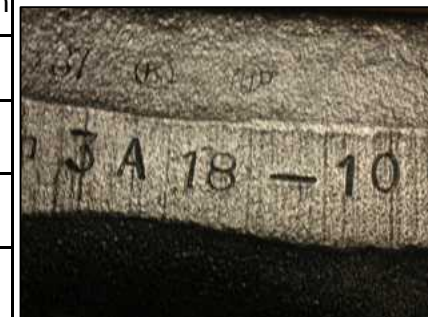
* Renewed Piston Pin Metal. No. 3A18-10 Boss 0.5mm Over Size Machined up.

UNIT 1/100 mm
Temp 25.3

3A18-10 (92-12)	Before Recondition		Out of Metal		Repaired to Boss		Renewed to Metal		After Recondition	
	82	+8 ~ +10	88	0 ~ +2.2	88	0 ~ +2.2	82	+8 ~ +10	82	+8 ~ +10
	X	Y	X	Y	X	Y	X	Y	X	Y
D1	9.6	+17.0	+2.3	+5.1	+0.1	+0.1	-45.0	-46.0	+8.3	+8.6
D2	9.6	+1.8	+3.2	+5.3	+0.1	+0.2	-44.0	-46.3	+8.2	+8.5
