# CONNECTING ROD (RECONDITIONED)

MAKER	YANMAR	ENGINE MODEL	M200L
DESCRIPTION	CONNECTING ROD without Crankpin Metal	PARTS NO.	741616-23010-C
INSPECTION NO.	8-2

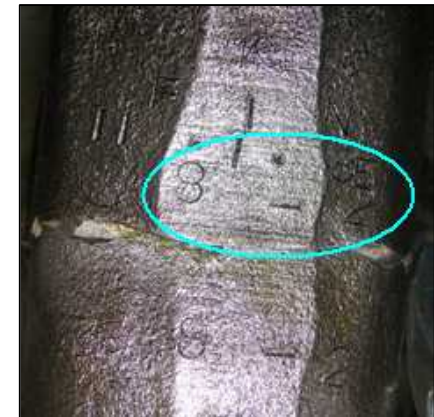
\* Renewed Piston Pin Metal. No. 8-2 Boss 0.5mm Over Size Machined up.

8-2 (84-12)	Before Recondition		Out of Metal		Repaired to Boss		Renewed to Metal		After Recondition	
	82	+8 ~ +10	88	0 ~ +2.2	88	0 ~ +2.2	82	+8 ~ +10	82	+8 ~ +10
	X	Y	X	Y	X	Y	X	Y	X	Y
D1	+9.7	+24.6	+0.5	+4.5	+0.1	+0.2	-38.5	-43.7	+8.0	+8.2
D2	+10.8	+25.9	+0.3	+6.5	+0.1	+0.1	-38.3	-44.0	+8.0	+8.2
