6N18L-N PISTON (RECONDITIONED)

MAKER	YANMAR	ENGINE MODEL	6N18L-N
DESCRPTION	PISTON ASSY (RECONDITION)	PARTS NO.	146673-22451-C
INSPECTION NO.	M433

INSPECTION RECORDS M433

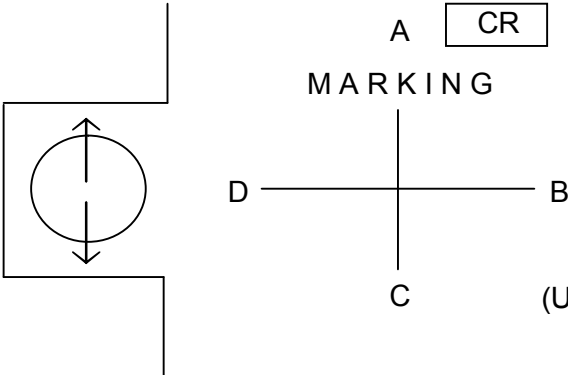
MARKING

Clearance After Recondition.

1 — 4.5mm + 0.045 ~ + 0.07

2 — 4.0mm + 0.04 ~ + 0.07

3 — 6.0mm + 0.020 ~ +0.35

(Unit mm)

Cr Plating Ring grooves.
Remarks : Defric Coating Finished.

※ Do not use the 3-face Cr-plated top ring.
Be sure to use the item for piston ring groove repaired plating (No. 147673-22950).

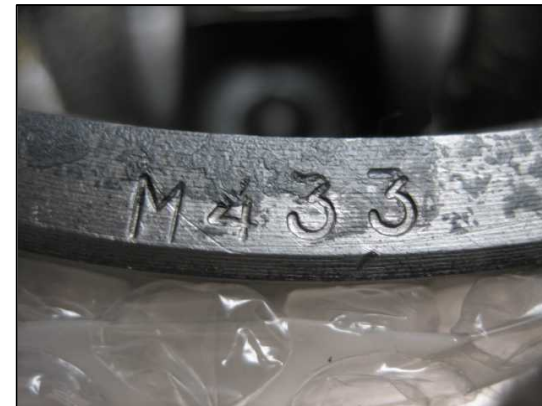
INSPECTION NO. M433

A	B	C	D
1	4.565	4.565	4.565	4.57
2	4.065	4.065	4.055	4.065
3	6.03	6.03	6.03	6.03
