6N18L-N PISTON (RECONDITIONED)

MAKER	YANMAR	ENGINE MODEL	6N18L-N
DESCRPTION	PISTON ASSY (RECONDITION)	PARTS NO.	146673-22451-C
INSPECTION NO.	M443

INSPECTION RECORDS M443

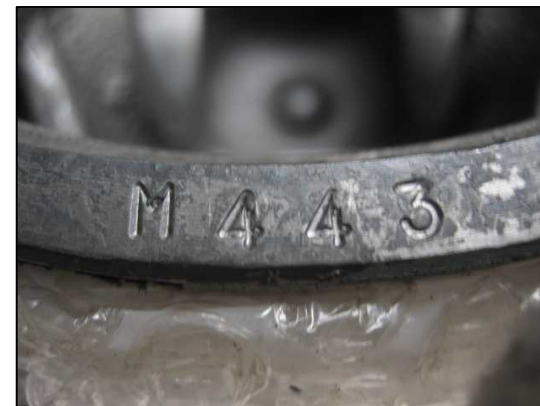
INSPECTION NO. M443

A	B	C	D
1	4.57	4.57	4.56	4.56
2	4.055	4.055	4.05	4.05
3	6.04	6.04	6.04	6.03

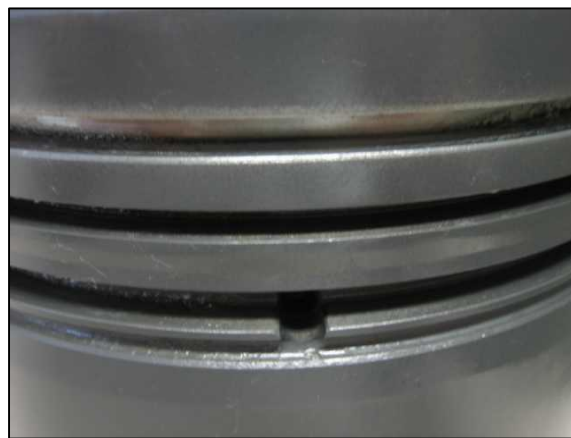
RING GROOVES FOR RECOATED
