# 6N18L-N PISTON (RECONDITIONED)

MAKER	YANMAR	ENGINE MODEL	6N18L-N
DESCRPTION	PISTON ASSY (RECONDITION)	PARTS NO.	146673-22451-C
INSPECTION NO.	M587

## INSPECTION RECORDS M587

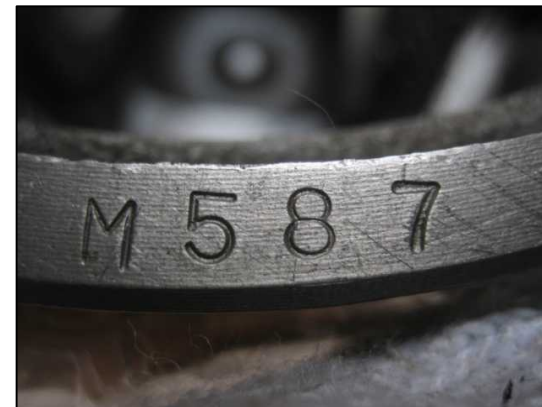
INSPECTION NO. M587

A	B	C	D
1	4.57	4.57	4.56	4.565
2	4.07	4.07	4.06	4.07
3	6.04	6.05	6.05	6.06

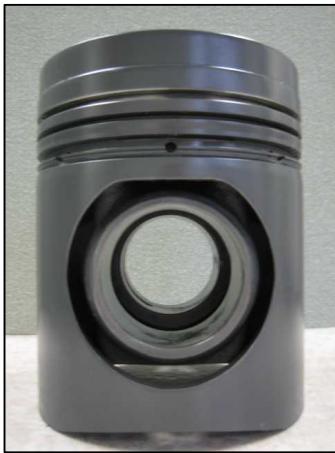
DEFRIC COATING FINISHED

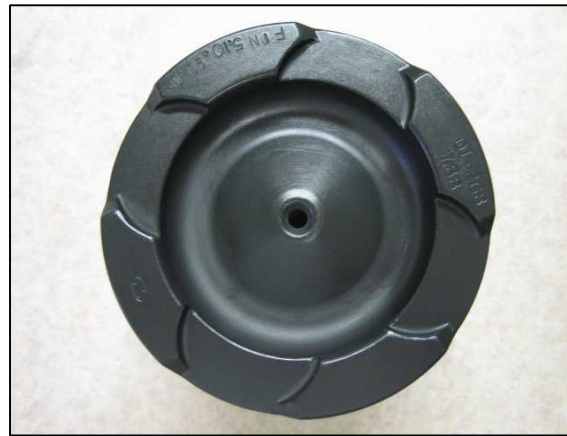
DEFRIC COATING FINISHED

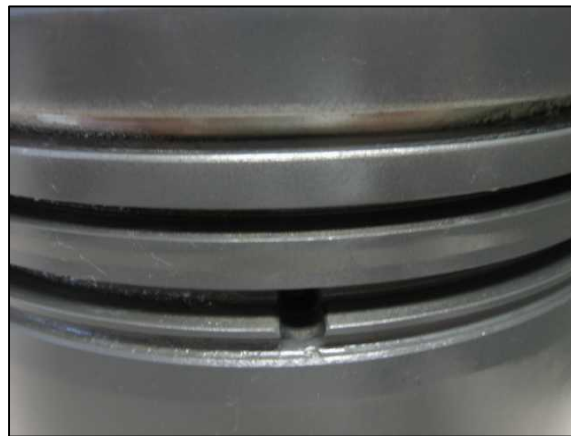
RING GROOVES FOR RECOATED
