# 6N18L-N PISTON (RECONDITIONED)

MAKER	YANMAR	ENGINE MODEL	6N18L-N
DESCRPTION	PISTON ASSY (RECONDITION)	PARTS NO.	146673-22451-C
INSPECTION NO.	M597

## INSPECTION RECORDS M597

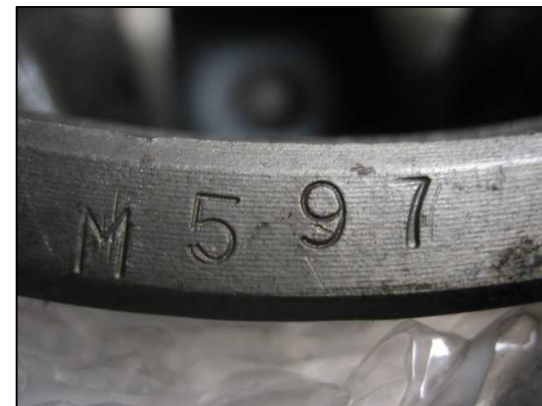
INSPECTION NO. M597

A	B	C	D
1	4.55	4.555	4.555	4.56
2	4.10	4.10	4.11	4.10
3	6.04	6.03	6.04	6.03

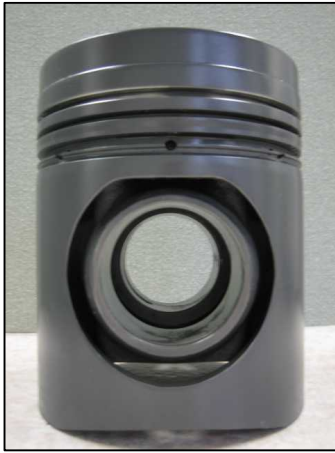
DEFRIC COATING FINISHED

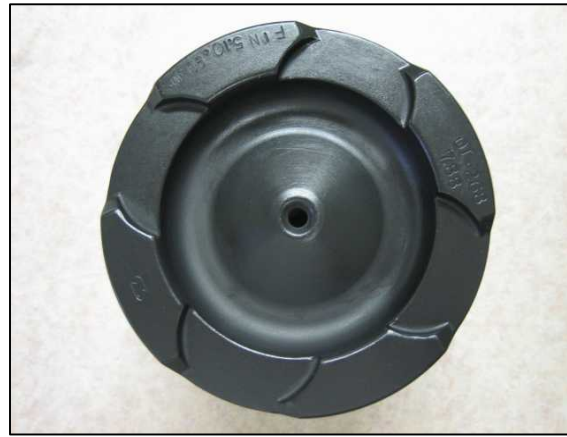
DEFRIC COATING FINISHED

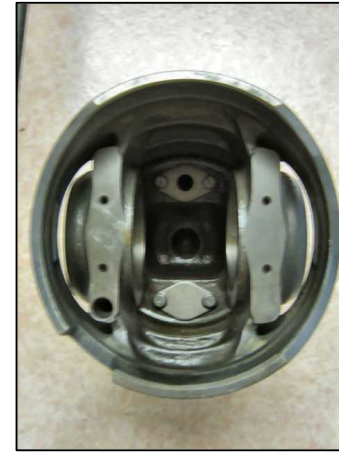
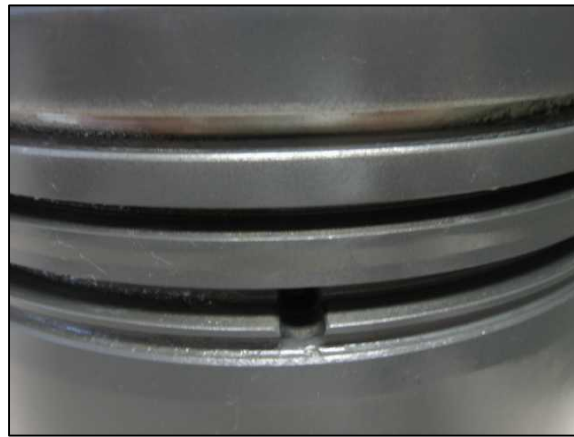
RING GROOVES FOR RECOATED
