6N18L-N PISTON (RECONDITIONED)

MAKER	YANMAR	ENGINE MODEL	6N18L-N
DESCRPTION	PISTON ASSY (RECONDITION)	PARTS NO.	146673-22451-C
INSPECTION NO.	M600

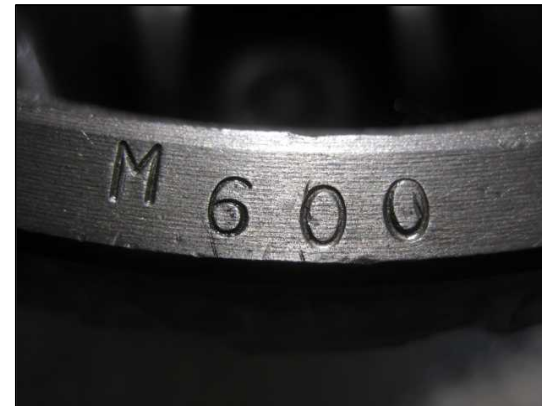
INSPECTION NO. M600

INSPECTION RECORDS M600

A	B	C	D
1	4.56	4.565	4.56	4.565
2	4.06	4.06	4.055	4.06
3	6.03	6.04	6.05	6.04

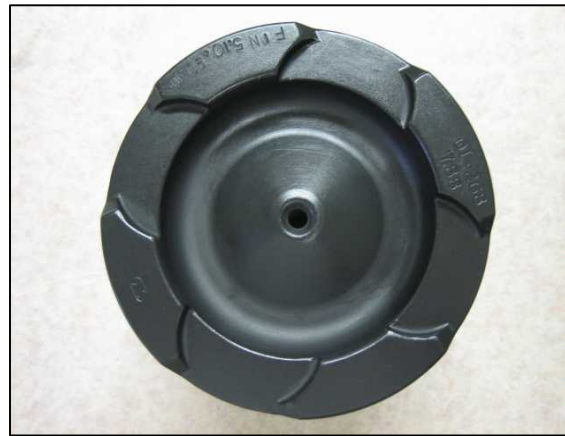
DEFRIC COATING FINISHED
