6N18L-N PISTON (RECONDITIONED)

MAKER	YANMAR	ENGINE MODEL	6N18L-N
DESCRPTION	PISTON ASSY (RECONDITION)	PARTS NO.	146673-22451-C
INSPECTION NO.	M607

INSPECTION RECORDS M607

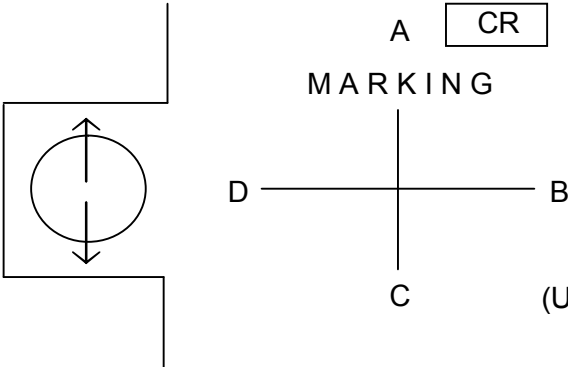
MARKING

Clearance After Recondition.

1 — 4.5mm + 0.045 ~ + 0.07

2 — 4.0mm + 0.04 ~ + 0.07

3 — 6.0mm + 0.020 ~ +0.35

Cr Plating Ring grooves.
Remarks : Defric Coating Finished.

※ Do not use the 3-face Cr-plated top ring.
Be sure to use the item for piston ring groove repaired plating (No. 147673-22950).

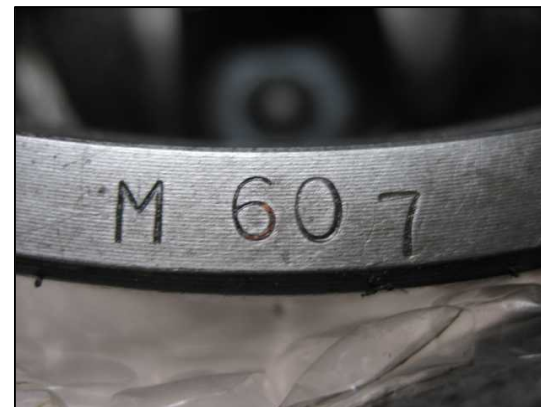
INSPECTION NO. M607

A	B	C	D
1	4.56	4.565	4.56	4.565
2	4.06	4.06	4.06	4.06
3	6.03	6.03	6.03	6.03

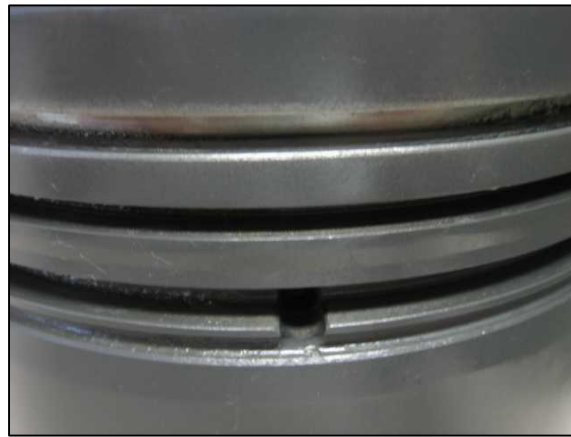
RING GROOVES FOR RECOATED
